Front Seat Squeak Noise (Apply Lubricant)

TECHNICAL SERVICE BULLETIN

Reference Number(s): 06-08-50-007, Date of Issue: June 28, 2006

Affected Model(s): 2006 Chevrolet HHR

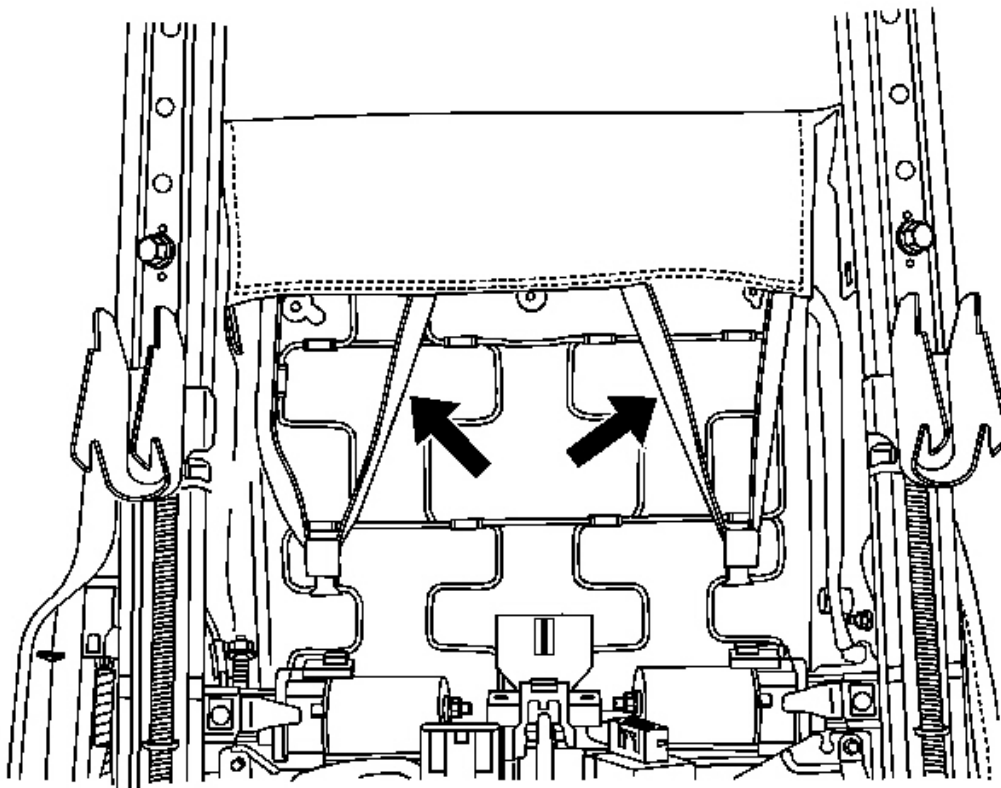
Fig. 1: Removing Elastic Straps
Courtesy of GENERAL MOTORS CORP.

2. Reach under the seat to remove the two elastic straps for the kick plate.

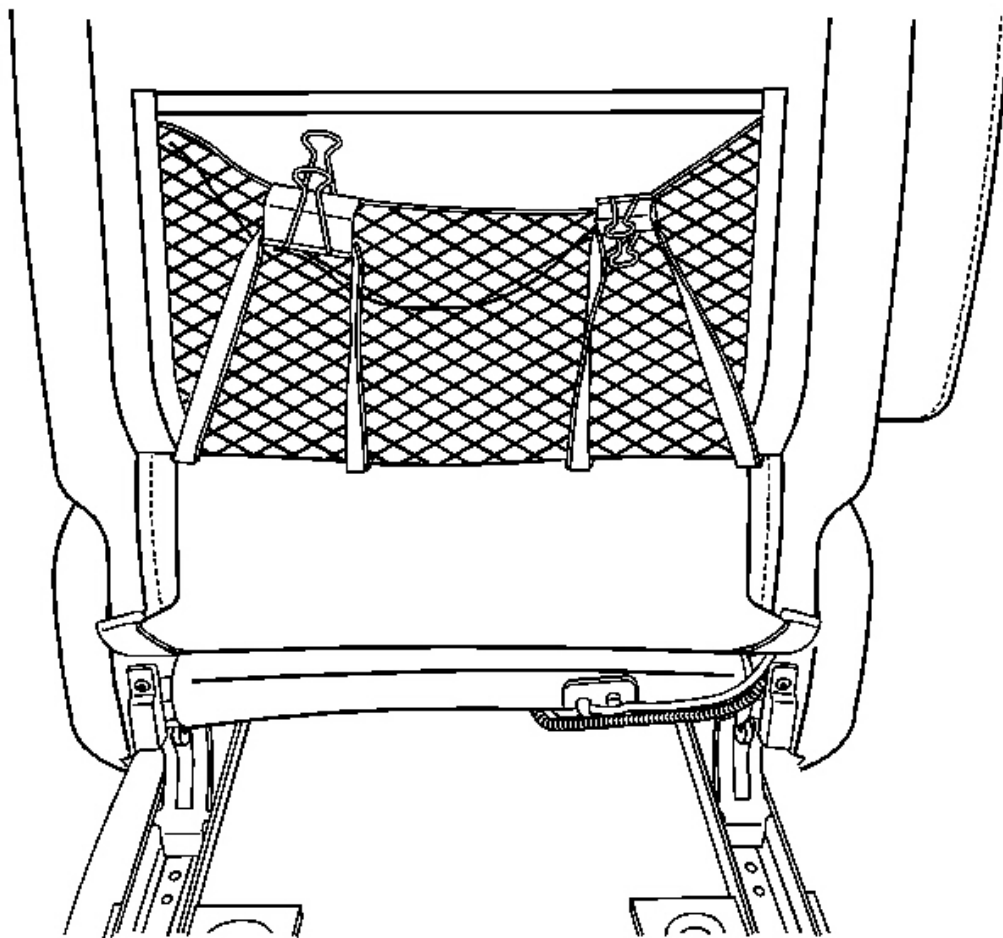
Fig. 2: Supporting Kick Plate
Courtesy of GENERAL MOTORS CORP.

3. Support the kick plate with two clips. Refer to the illustration above.
4. Remove the screw from the plastic trim on each side of the seat.
5. Pull the trim outward.
6. Protect the carpet from spraying the lubricant in the next step.

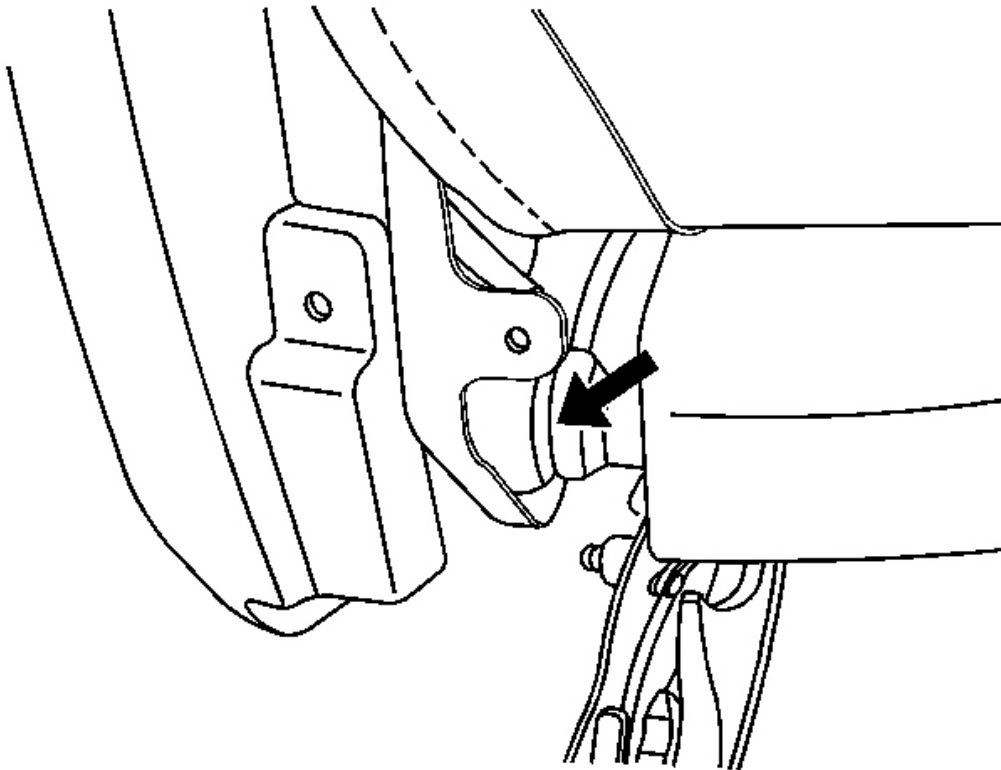
Fig. 3: Locating Lift Arm Pivot Point
 Courtesy of GENERAL MOTORS CORP.

7. Lubricate the lift arm pivot point. Refer to the illustration above.
8. Reinstall the plastic trim and the kick plate.
