Information on Stage Kit TMAP Sensor Modification

TECHNICAL SERVICE BULLETIN

Reference Number(s): 09-06-04-009, Date of Issue: March 02, 2009

Affected Model(s): 2008-2009 HHR SS; Equipped with 2.0L Engine (VIN X - RPO LNF)

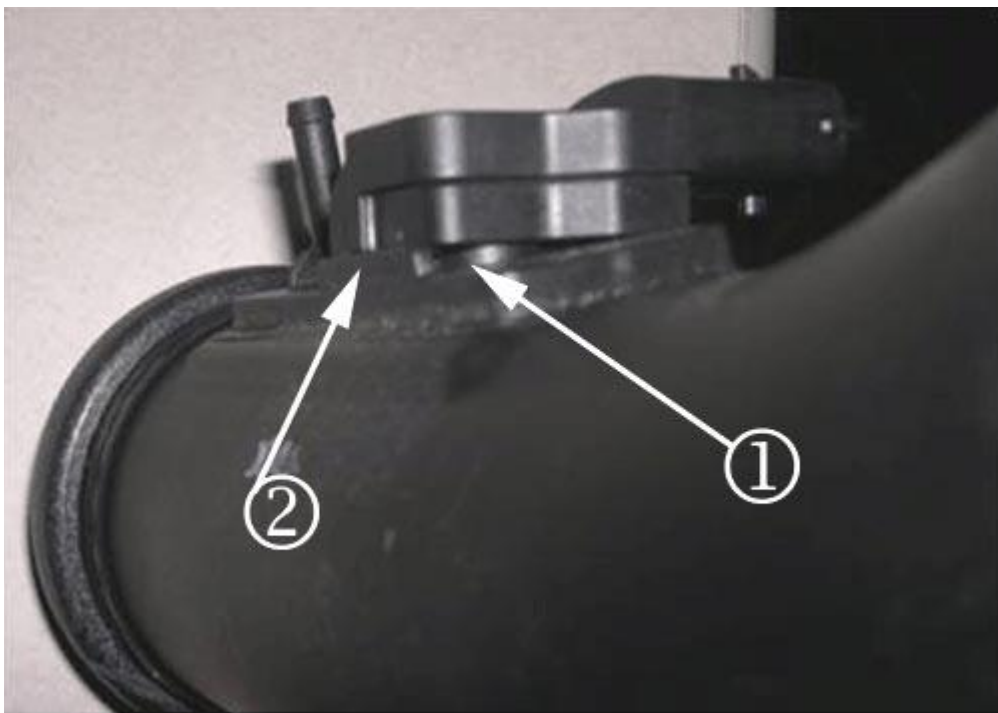
Fig. 1: View Of Duct

Inspect the TMAP sensor when mounted on the charge air duct. Note how the TMAP sensor is not mounted flush on the duct (1).

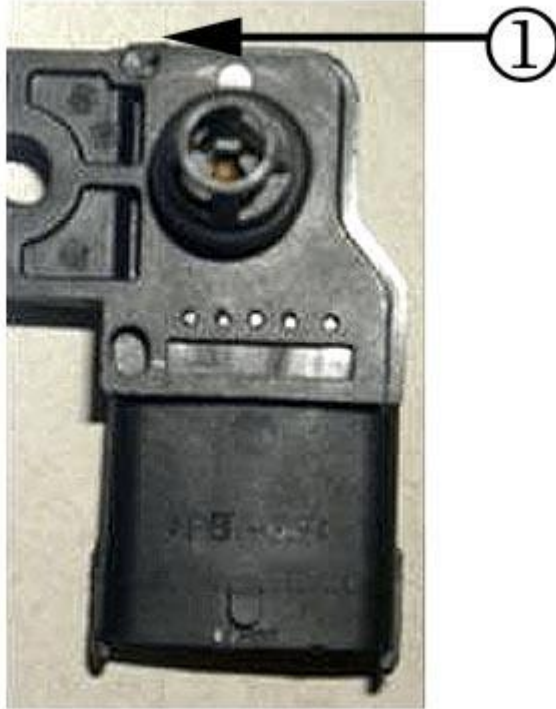
Fig. 3: View Of TMAP Sensor
Courtesy of GENERAL MOTORS CORP.

The TMAP sensor after the boss was removed (1).

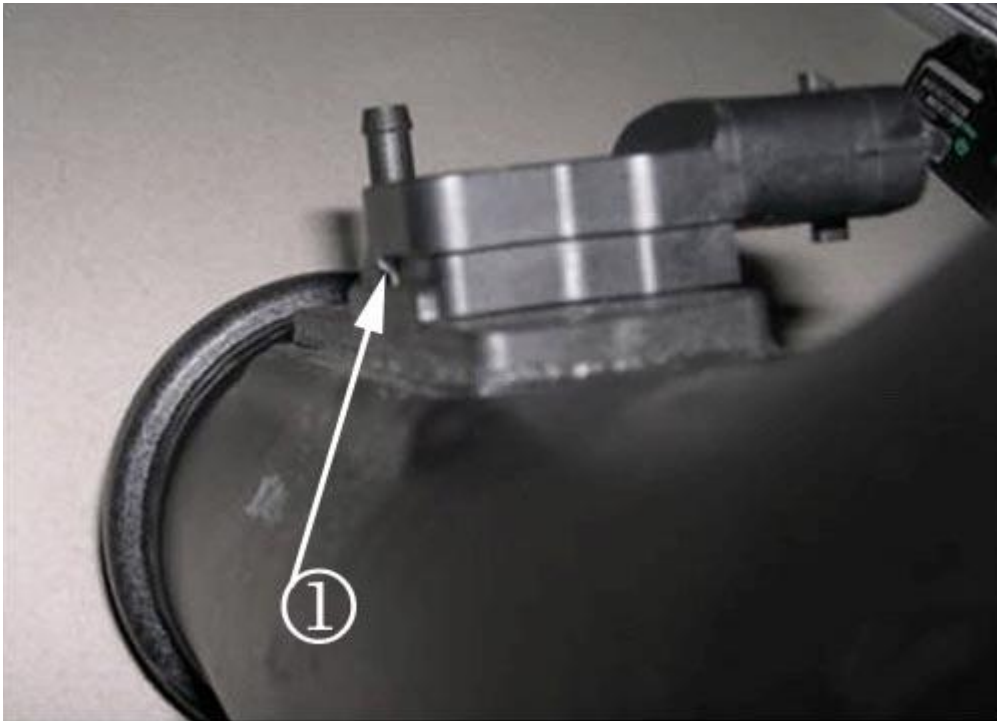
Fig. 4: View Of Mounted TMAP Sensor

The TMAP sensor mounted flush onto the duct (1).
